Gordon River Monitoring Annual Report 2015–16

September 2016

This Gordon River Monitoring Annual Report presents the results of the monitoring undertaken on 16-17 April 2016 pursuant to the Gordon River Monitoring Program.

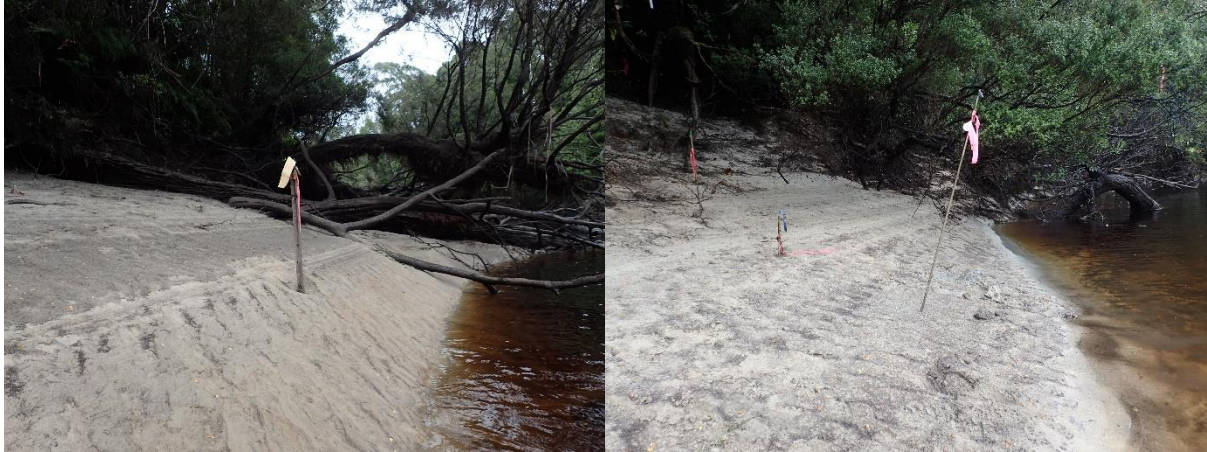
- There was widespread evidence of erosion through bank scour; smooth bank surfaces lacked any evidence of deposition, and there was a large reduction in the amount of sand on some banks, especially in zones 3 and 4 (Figure 3-9, Figure 3-10);
- Mud veneers and algae growth were present on bank toes in zones 1 and 2 but were not observed in zones 3 and 4. These deposits and growth are likely due to the low discharge from the power station in the month prior to monitoring (Figure 3-11);

Figure 3-9: Examples of bank toes showing scour and lack of deposition of organic debris at sites 2D (left) and 3E (right).

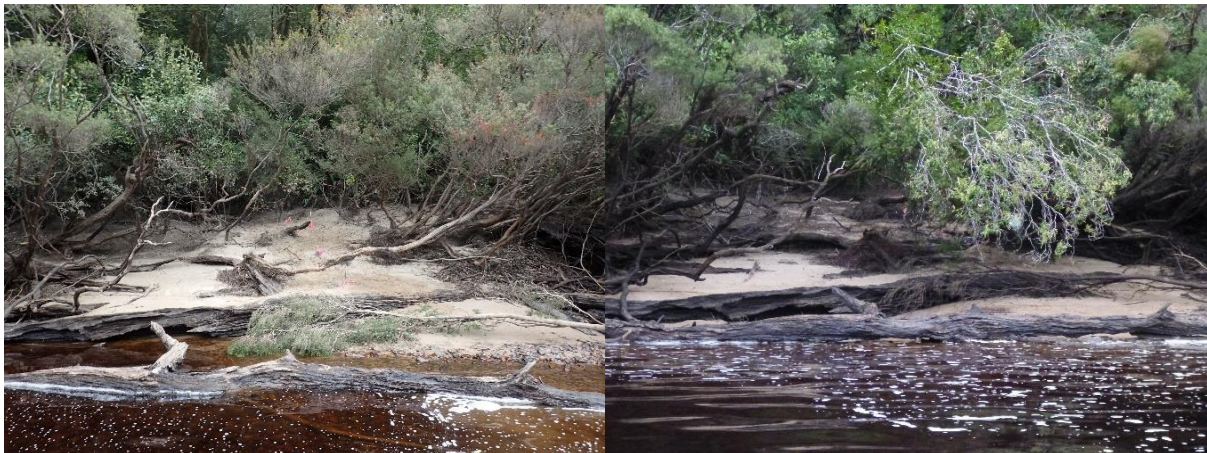
The increase in erosion in zones 3 and 4 was reflected in the photo monitoring results, with sand deposits on bank toes at erosion pin sites noticeably reduced in April 2016 as compared to October 2014. The photo monitoring results of the long term disturbance sites show little change between the current and previous monitoring periods. The changes that were noted are consistent with previous findings.

Figure 3-10: Comparison of erosion pin site 4D in October 2014 (left) and April 2016 (right) showing a large reduction in sand deposits.

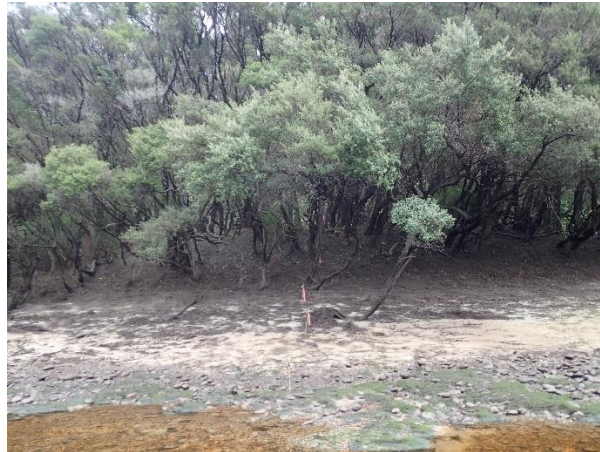
- The exposed sand bar at the upstream end of zone 2 (in the pool downstream of the Albert River and upstream of the first riffle) that was first noted in October 2014 remains exposed. Assuming it has been present since first observed, it is likely that this new bar is related to the altered hydraulics of the river following increased discharge from the Gordon Power Station rather than a one-off event in the catchment in 2014;

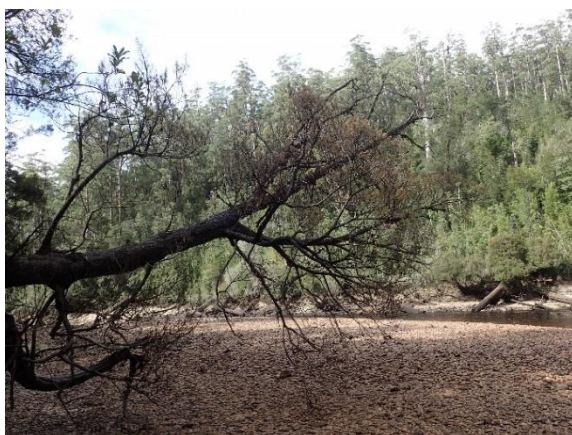
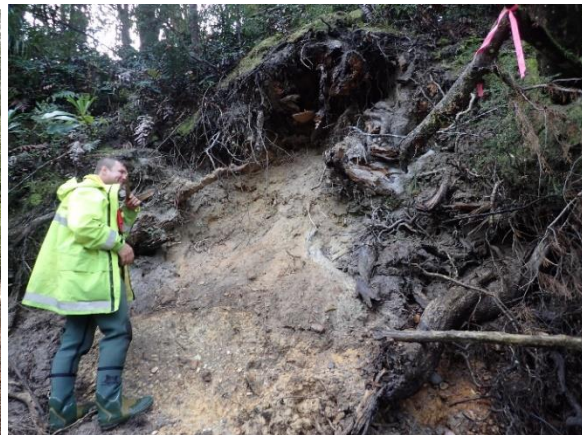
Site 2H contains 2 parallel profiles of erosion pins. One set (Pins H1 – H3) is in a tea tree bank, and the other (H4 - H7) is immediately downstream in an area where the tea tree has been lost and the steep bank is prone to seepage processes. The erosion pin results have captured the movement of a large Huon pine down slope that buried pin H4, and the flattening of the seepage affected bank. The erosion pin results in April 2016 show an increased level of erosion in the 'tea tree' pins (1-3), and continued flattening of the bank through deposition at pins H5 and H6 (Figure 3-17).

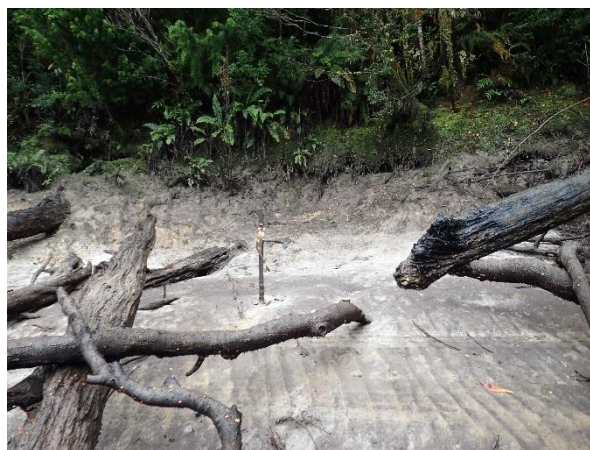
Site 2D is located on the inside of a sharp bend and the site has shown cycles of flattening of the bank toe (pin D4) and erosion of the upper bank followed by erosion of the toe (Figure 3-16). A photo of the site (Figure 3-9) shows erosional features on the bank toe. Deposition was recorded at pins located downslope of the break in slope at the rear of the bank, consistent with the erosion of the bank face and deposition downslope.

Site 2E is located on the opposite bank from site 2D and is on a very active bank with respect to seepage erosion processes (Figure 3-17). The toe recorded a long period of deposition, associated with seepage processes, but in the past few years has shown erosion. This may reflect the exhaustion of material available for seepage, or an increase in scour, as the morphology of the bank is becoming more concave (Figure 3-18). Pin E1 is located in a cavity on the bank, and its variability is partially attributable to difficulties associated with measuring. The recent erosion pin results reflect the hummocky topography of the bank, and the reduction in slope of the bank face.

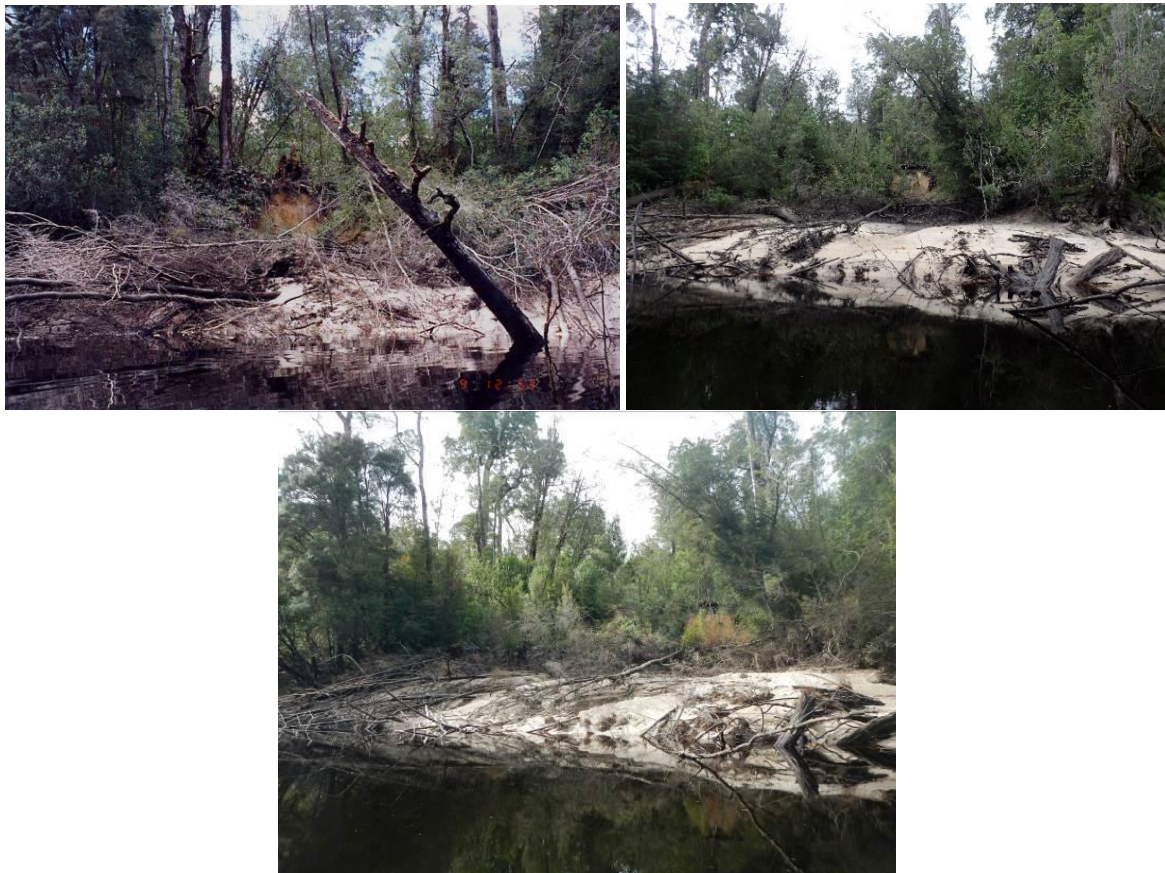
Compared to the photo monitoring results obtained in March 2014 and October 2014, the observed changes in April 2016 were generally small. This is consistent with the long-term results that have overwhelmingly indicated that once a disturbance occurs, there is little additional upstream or downstream disturbance, with subsequent changes typically limited to the loss, addition or re-arrangement of woody debris on bank toes, the loss of overhanging vegetation (attributable to very strong root mats present in the Gordon River), and an increase in vegetation on the disturbance upslope of the power station controlled high water level. An exception is site 2-15 where a large tree-fall in ~2000 induced additional vegetation loss and bank changes for approximately a decade. The site is now showing low levels of change (Figure 3-21).

Figure 3-21: Photo monitoring site 2-15 in 2002 (top left), 2014 (top right) and 2016 (bottom).

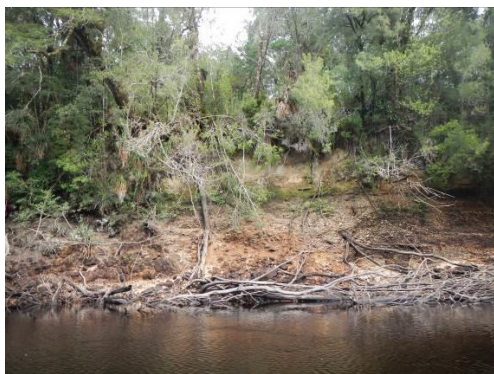
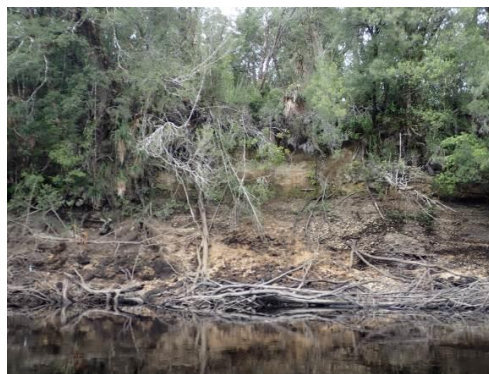
Site 2–12: Left bank

No suitable photo obtained in April 2016
