# Gordon River Monitoring Report 2016–18

September 2018

This Gordon River Monitoring Annual Report presents the results of the monitoring undertaken on 2-3 March 2018 pursuant to the Gordon River Monitoring Program.

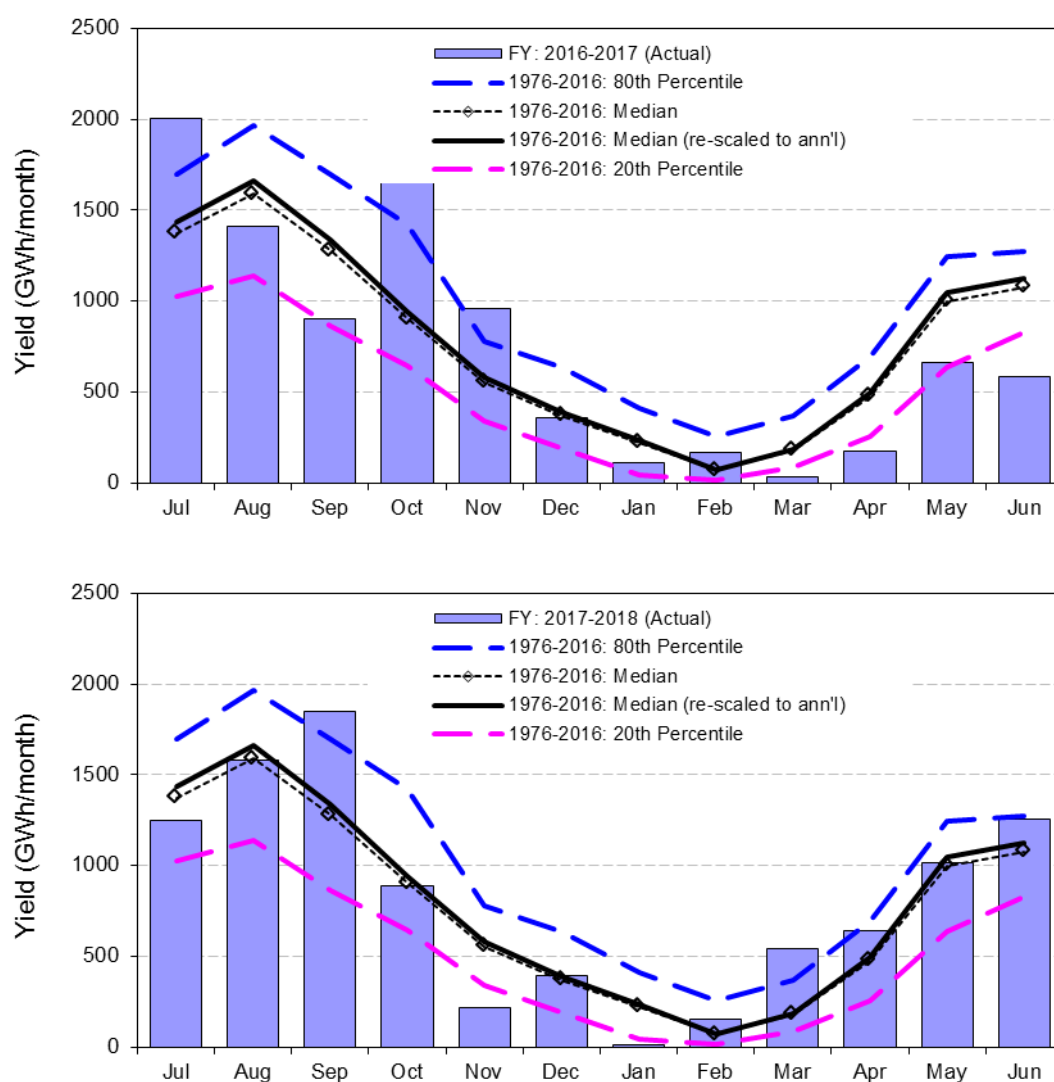
**Figure 2-6:** Monthly total system yield for 2016–17 (top) and 2017-18 (bottom) compared to the long-term median, 20th and 80th percentiles for 1976–2016.

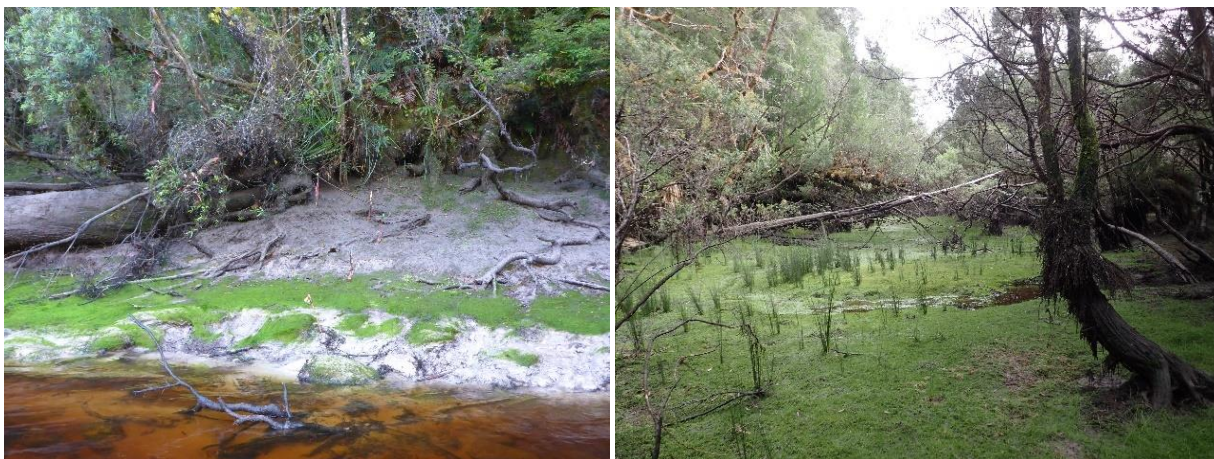
**Figure 3-8:** Algae, mosses and rushes on the bank toe in zone 3 (left) and in the backwater behind erosion pin site 2A in zone 2 (right).

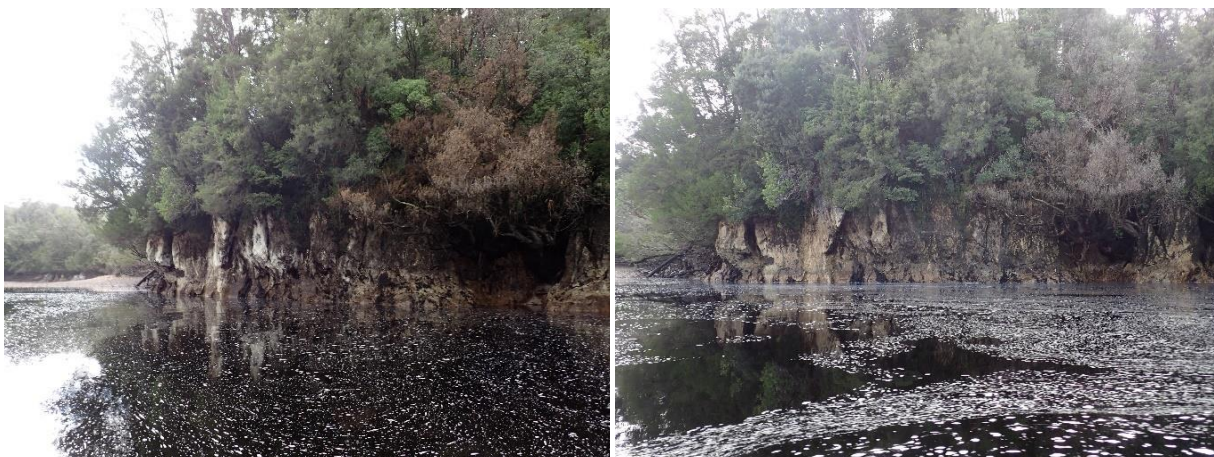
- The dieback of trees that was first observed in March 2014 appears to have ceased, with no new trees along the water line observed to be browning (Figure 3-9). The dead trees remain standing;

**Figure 3-9:** No additional trees along the power station high water level were observed as dying in 2018. The trees observed in (left) 2016 remain standing in 2018 (right). Photo from zone 2.

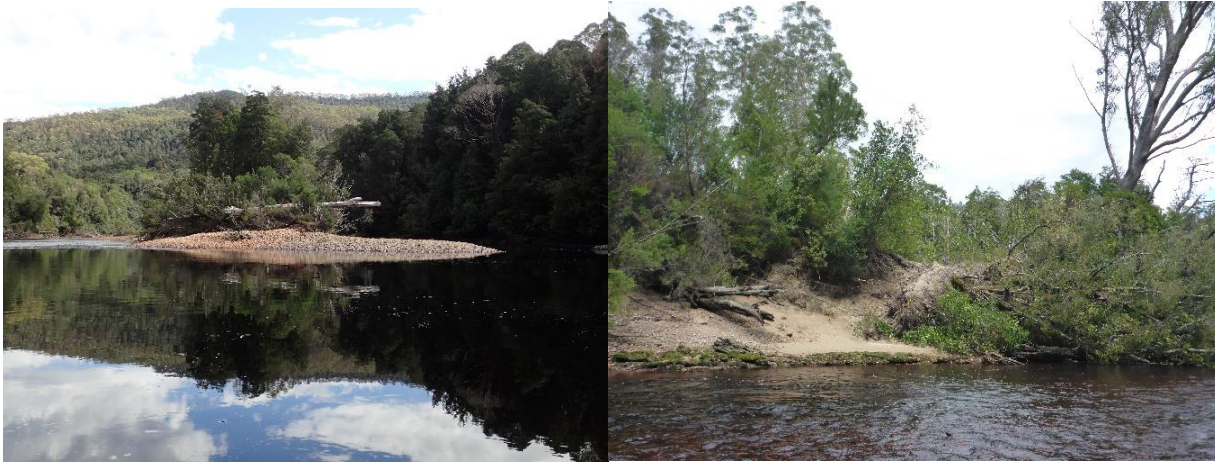
**Figure 3-10.** Flood debris on island downstream of erosion pin site 4E (G9 island) in zone 4 (left), and Large treefall on the north side of the same island(right).

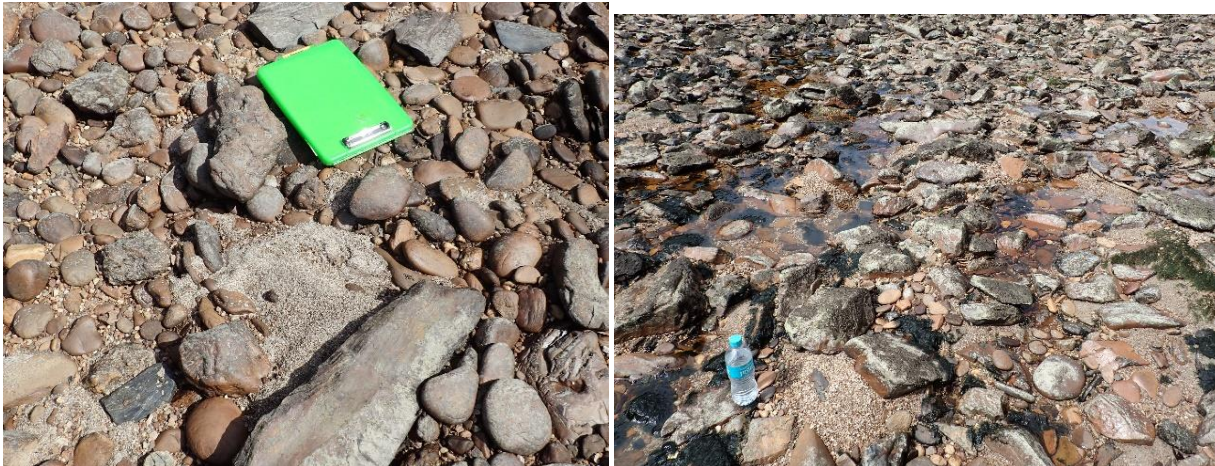
**Figure 3-11.** Deposition of coarse sand and gravels in quiescent areas of cobble bars in (left) zone 2 upstream of the Splits and (right) in zone 3.

- Deposits of coarse sand and gravel were observed in hydraulically quiescent areas of cobble bars in the lower section of zone 2 (upstream of the Splits) and in zones 3 and 4. The deposits are consistent with low power station usage (Figure 3-11).

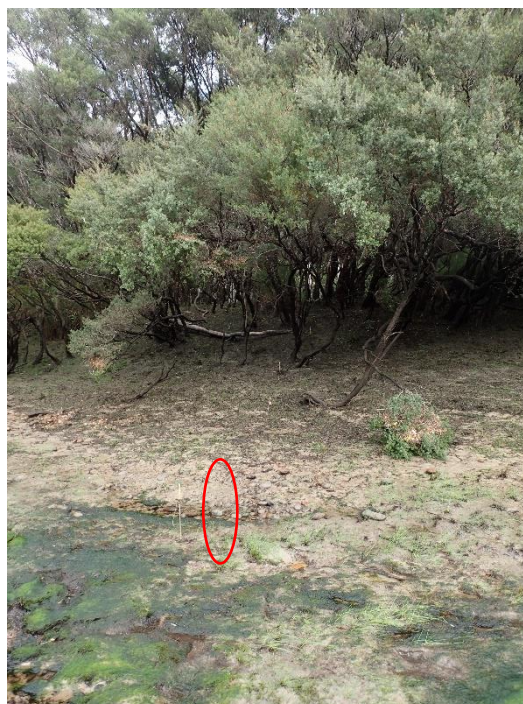
**Figure 3-17:** Erosion pin site 2A showing location of pin 8 in cobbles and affected by the growth and presence of vegetation.

Site 2A is also located on a bank supporting tea tree. The bank separates the main channel from a back channel which is active when the power station is in use. Pins 2A1 – 2A4 and pin 2A8 are on the river side, with pins 2A5 – 2A7 on the back-channel side (Figure 3-16). The pins on the river side have shown little change since monitoring began, except at pin 2A8 where small changes associated with the growth of vegetation and trapping of fine sediment has occurred (Figure 3-17). The pins on the back channel show low rates of change associated with slow seepage process. Pin 2A7 has recorded the greatest changes due to a scour hole forming at the base of the pin and then refilling over time. These changes are an artefact of the pin and do not reflect changes to the back channel.

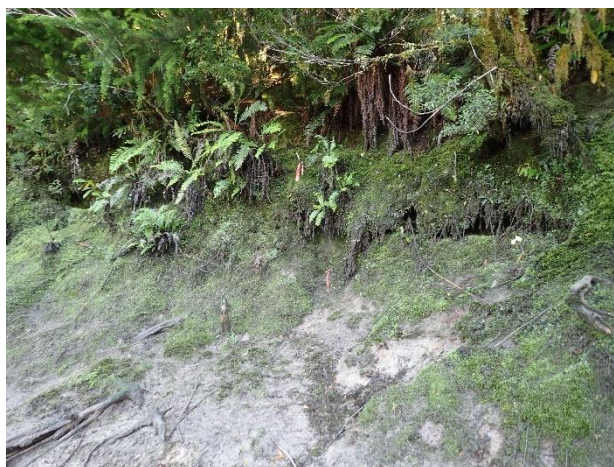
**Figure 3-19.** Photo of erosion pin site 2E showing establishment of mosses and ferns near previous seepage 'vents'.

Site 2E is located on the opposite bank from site 2D and is on a bank where seepage erosion was active during the pre-Basslink monitoring period, with the toe (2D4) recording a long period of deposition, associated with seepage processes (Figure 3-18) followed by erosion and another cycle of deposition. Pin 2E1 is located in a cavity on the bank, and its variability is partially attributable to difficulties associated with measuring. Over the past years, the site has recorded erosion more consistently than deposition, and the site has developed a concave shape, consistent with the exhaustion of material available for transport and deposition by seepage. In 2018, the site supported wide-spread mosses and ferns, indicating a high level of stability (Figure 3-19).

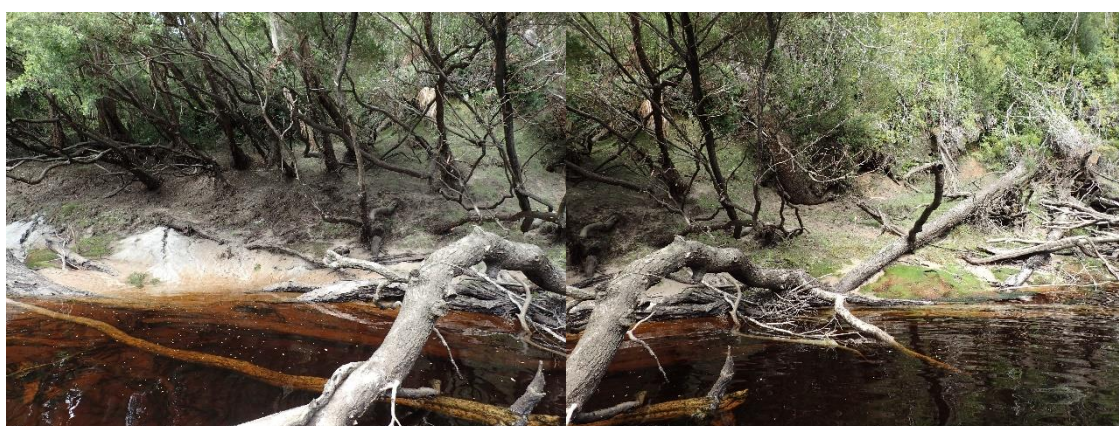
**Figure 3-20** Tea tree section of erosion pin site 2H showing steep bank face, erosion of root mat and rilling in the underlying sand bank (left), and 'seepage' section of site showing flatter bank toe and treefalls (right).

Site 2H contains 2 parallel profiles of erosion pins. One set (Pins 2H1 – 2H3) is in a tea tree bank, and the other (2H4 - 2H7) is located immediately downstream in an area where the tea tree has been lost and the steep, disturbed bank is prone to seepage processes (Figure 3-18). The erosion pin results have captured the movement of a large Huon Pine down slope that buried pin 2H4, and the flattening of the seepage affected bank (2H5 – 2H6). The erosion pin results in March 2018 show continued erosion in the tea tree pins (2H1 - 2H3), and little change to the relatively flat toe at pins 2H5 and 2H6 (Figure 3-20).

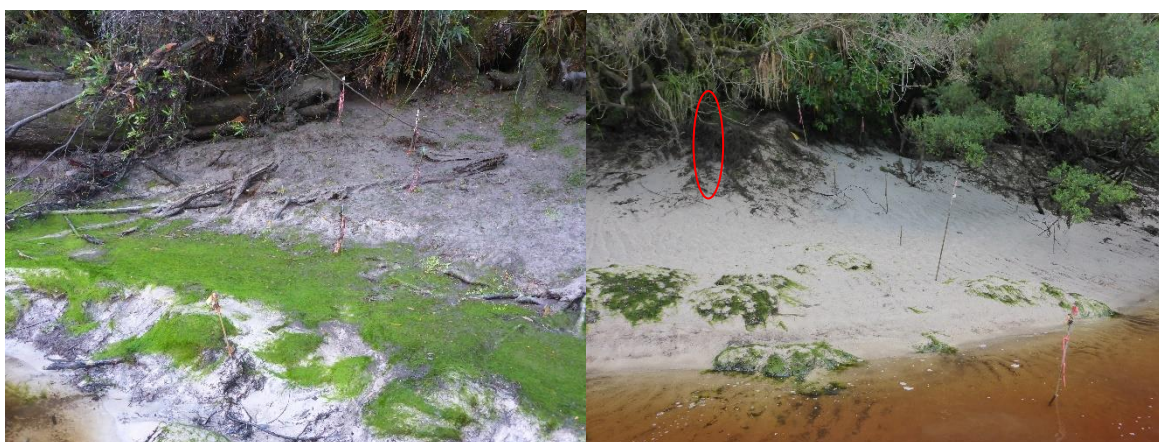
**Figure 3-22:** Site 3C (left), showing pins 3C4 located on the flat lying lower bank, and pin 3C5 on the bank toe in an area being scoured (right) Site 3E showing location of pin 3E2 at edge of root-mat.

Sites 3C is located on the right bank in zone 3 just upstream of the Compliance Site. This erosion pin site is affected by power station operations, inflows from the Orange River, and backwater effects from the Denison River. Pin 3C1 is in a cavity and has been lost due to bank collapse. Pin 3C55, which was located approximately at the  $55 \text{ m}^3\text{s}^{-1}$  flow level has been lost most likely due to erosion (based on high level of erosion recorded in March 2014).

Site 3E is located half way down zone 3 on the right bank, and is composed of a large sandy bank toe with tea tree on the higher bank. The root-mat is eroding, and since around 2013 the bank has shown higher rates of change (Figure 3-21). Most pins recorded high rates of deposition, attributable to some fluvial deposition, but also seepage processes associated with flattening of the bank face as the root-mat is lost. Pin 3E2, which recorded erosion, is located at the break in slope at the bank, near the edge of the eroding root-mat (Figure 3-22).

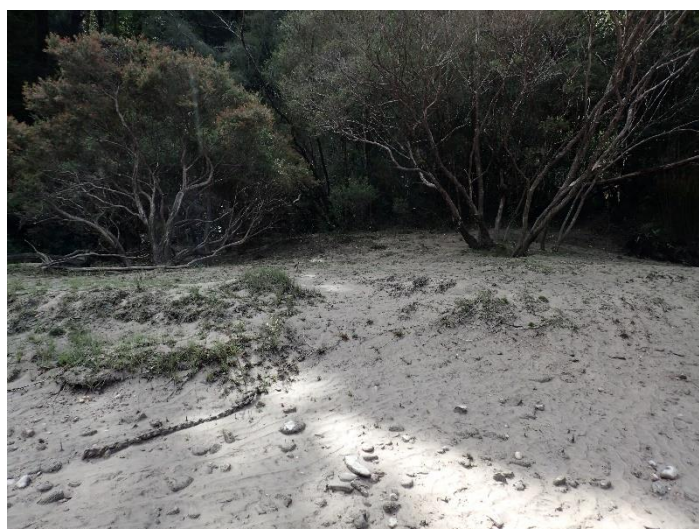
**Figure 3-24:** Erosion pin site 4H. Toe pin is located near scour chain (bottom left in photo) on steep part of bank. Vegetation is trapping sediment on the bank.

Site 4H is located at the downstream end of zone 4, upstream of Sunshine gorge near the confluence of the Harrison and Smith Creeks with the Gordon River. The pins show a similar trend in 2018 as recorded previously at the site (Figure 3-23). All pins except toe pin 4H5 show deposition that is partially attributable to flattening of the site over time due to seepage processes, and partially attributable to the fluvial deposition of sand. Sand in this area is likely derived from the nearby tributaries, and from the Gordon River with deposition occurring during periods of high flow when the Gordon experiences backwater effects in this area due to the proximity of Sunshine Gorge. During periods of low power station usage, vegetation increases on the banks and enhances sediment deposition. Pin 4H1 is located on a step area of the bank toe and is eroding.

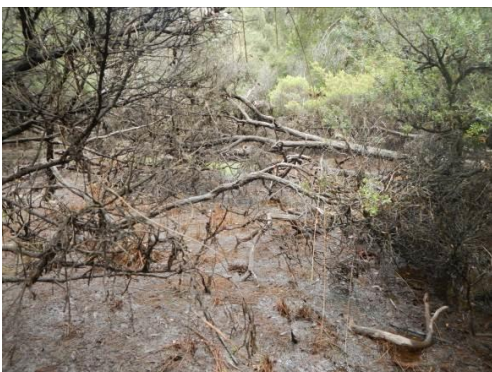
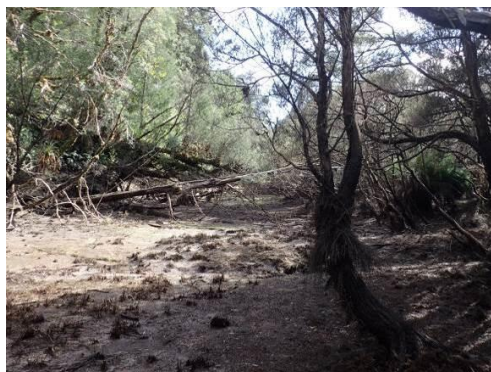
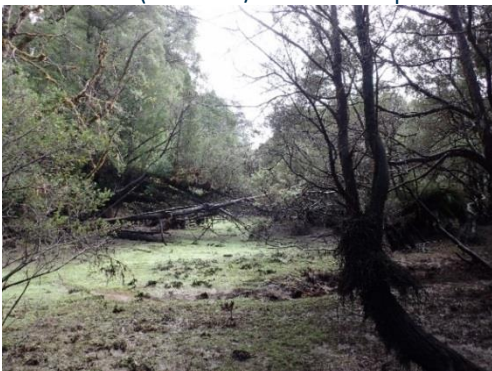
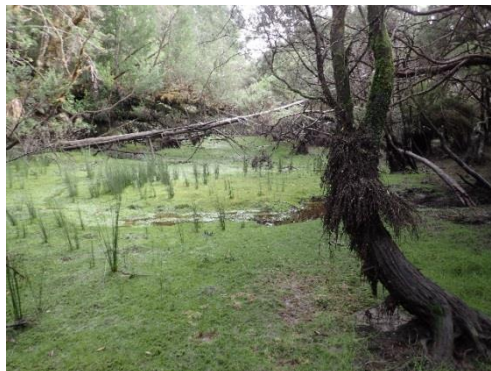
### Site 2-4: Backwater view upstream at site 2A

March 2014 (further d/s –moved to pins 6 and 7)
